Manhole Inspection Summary

Manhole # S29C__005MH

Insp Date: **5/12/09 7:31 AM**

Location Address: **MARTIN LUTHER KING BLVD** Cross Street: **N FRANKLIN ST**

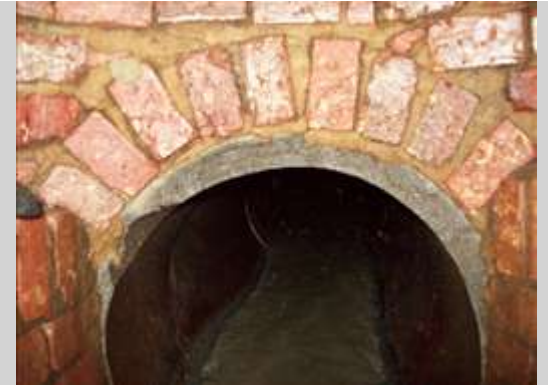
12 O'Clock Outflow

18 in. Circular Gravity Sewer
Pipe Out @ 12 O'Clock

Pipe Height: **14.4** (in.) Rod and Bar
Pipe Material: **Concrete** ☐ Pipe Lined
Invert Depth: **19.49** (ft.) Flow Characteristics: **Slow**
Deposits: ☒ None ☐ Mud ☐ Sludge ☐ Debris ☐ Grease
Silt Depth: (in.) Deposits Extent:
Infiltration: **None** Pipe Seal Cond: **Sound**

Drop: **None**

Connects To: **Manhole**

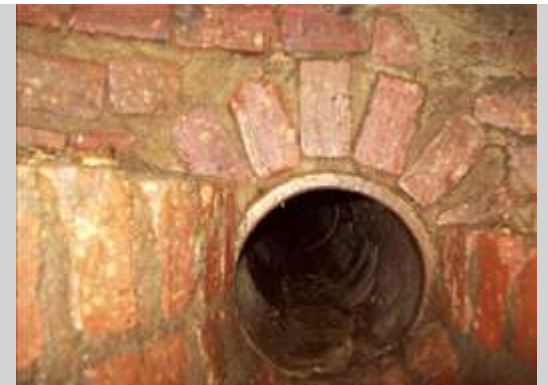
3 O'Clock Inflow

12 in. Circular Gravity Sewer
Pipe In @ 3 O'Clock

Pipe Height: **8.4** (in.) Rod and Bar
Pipe Material: **Concrete** ☐ Pipe Lined
Invert Depth: **18.81** (ft.) Flow Characteristics: **Slow**
Deposits: ☒ None ☐ Mud ☐ Sludge ☐ Debris ☐ Grease
Silt Depth: (in.) Deposits Extent:
Infiltration: **None** Pipe Seal Cond: **Sound**

Drop: **None**

Connects To: **Manhole**

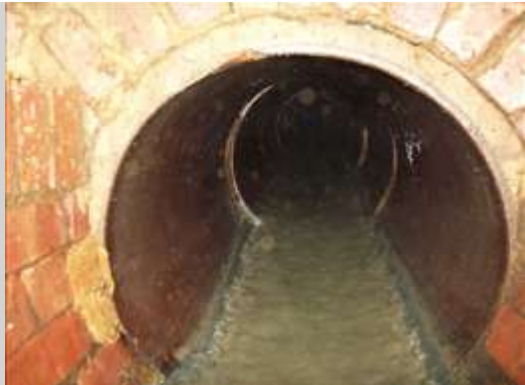
6 O'Clock Inflow

18 in. Circular Gravity Sewer

Pipe In @ 6 O'Clock

Pipe Height: **8.4** (in.) Rod and Bar

Pipe Material: **Concrete** ☐ Pipe Lined

Invert Depth: **19.01** (ft.) Flow Characteristics: **Slow**

Deposits: ☒ None ☐ Mud ☐ Sludge ☐ Debris ☐ Grease

Infiltration: **None** Pipe Seal Cond: **Sound**

Drop: **None**

Connects To: **Manhole**

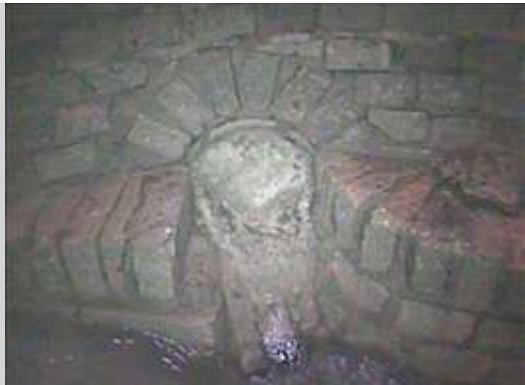
9 O'Clock Inflow

12 in. Circular Gravity Sewer

Pipe In @ 9 O'Clock

Pipe Height: (in.) Direct

Pipe Material: **Concrete** ☐ Pipe Lined

Invert Depth: **18.70** (ft.) Flow Characteristics: **None**

Deposits: ☒ None ☐ Mud ☐ Sludge ☐ Debris ☐ Grease

Infiltration: **None** Pipe Seal Cond: **Sound**

Drop: **None**

Connects To: **Stub connection / abandoned**
